# Liquid Nitrogen Bulk Storage Maintenance

Kenneth Anderle

September 19, 2016

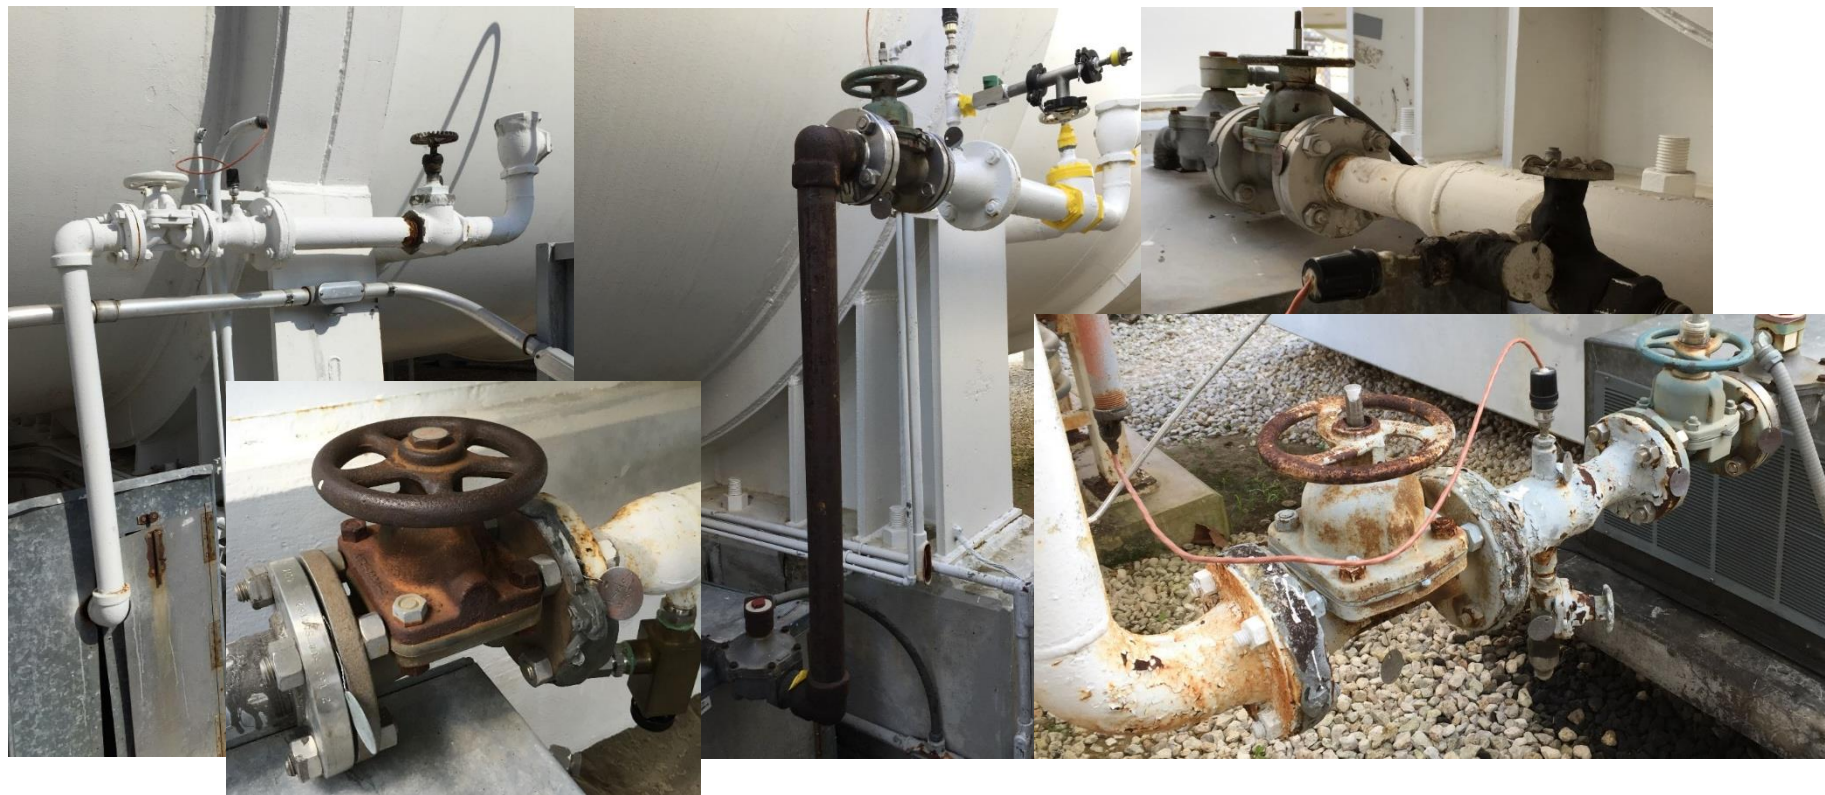
- Replace vacuum pipe spools from vacuum pumps to main tanks

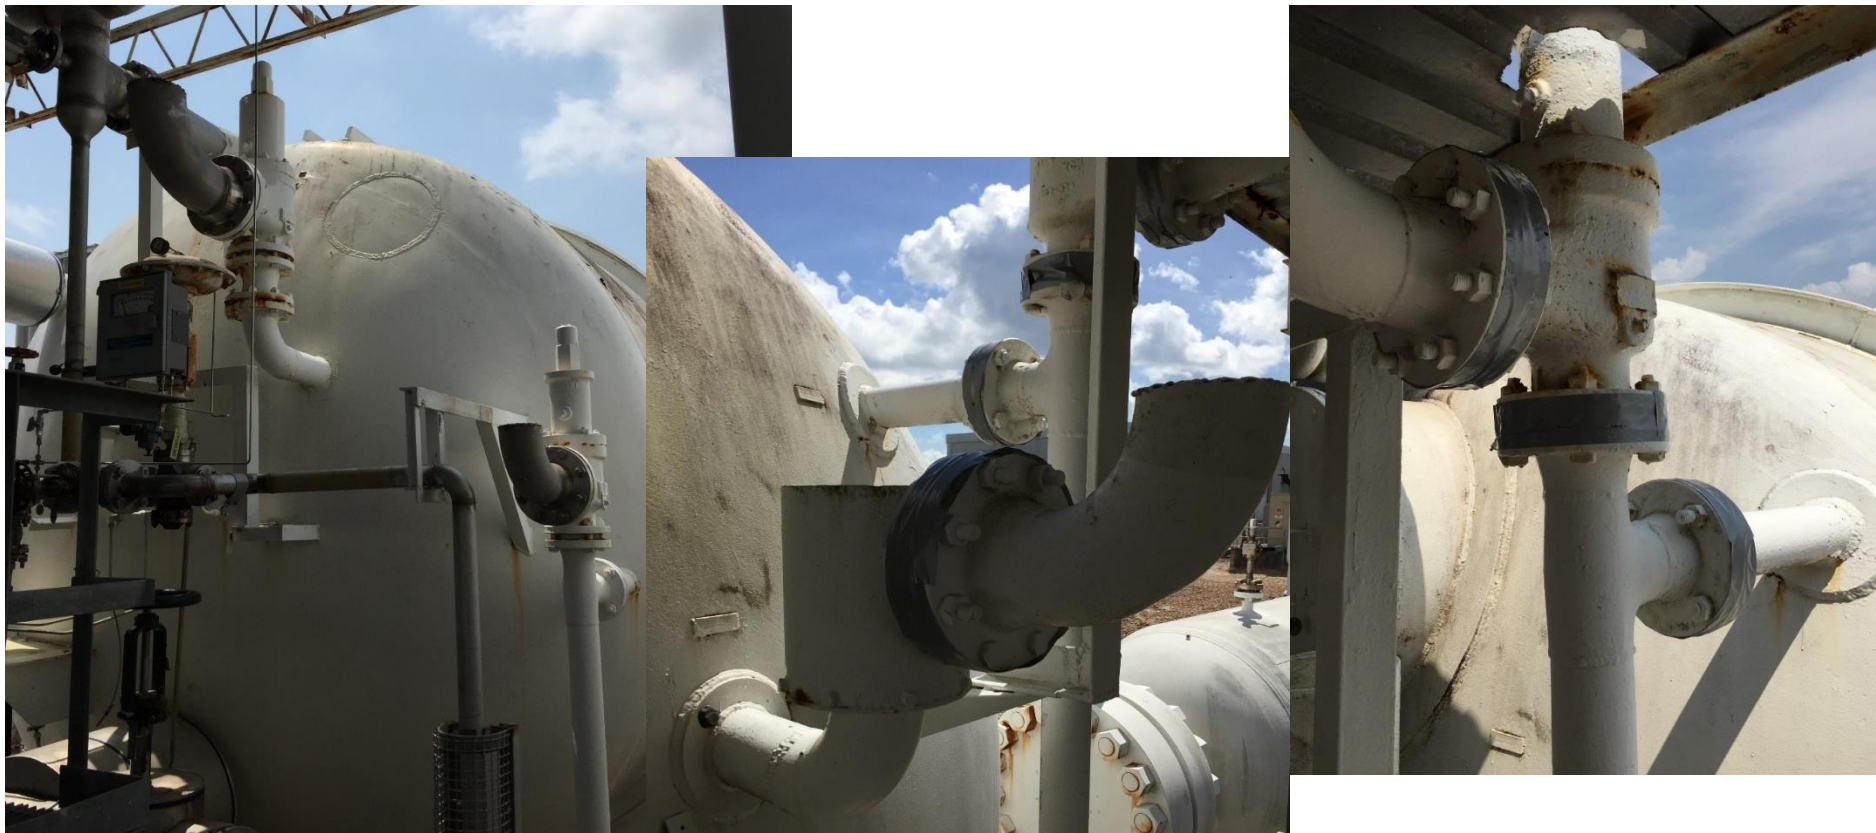
- Replace positive pressure relief devices on 2 tanks (vacuum side).

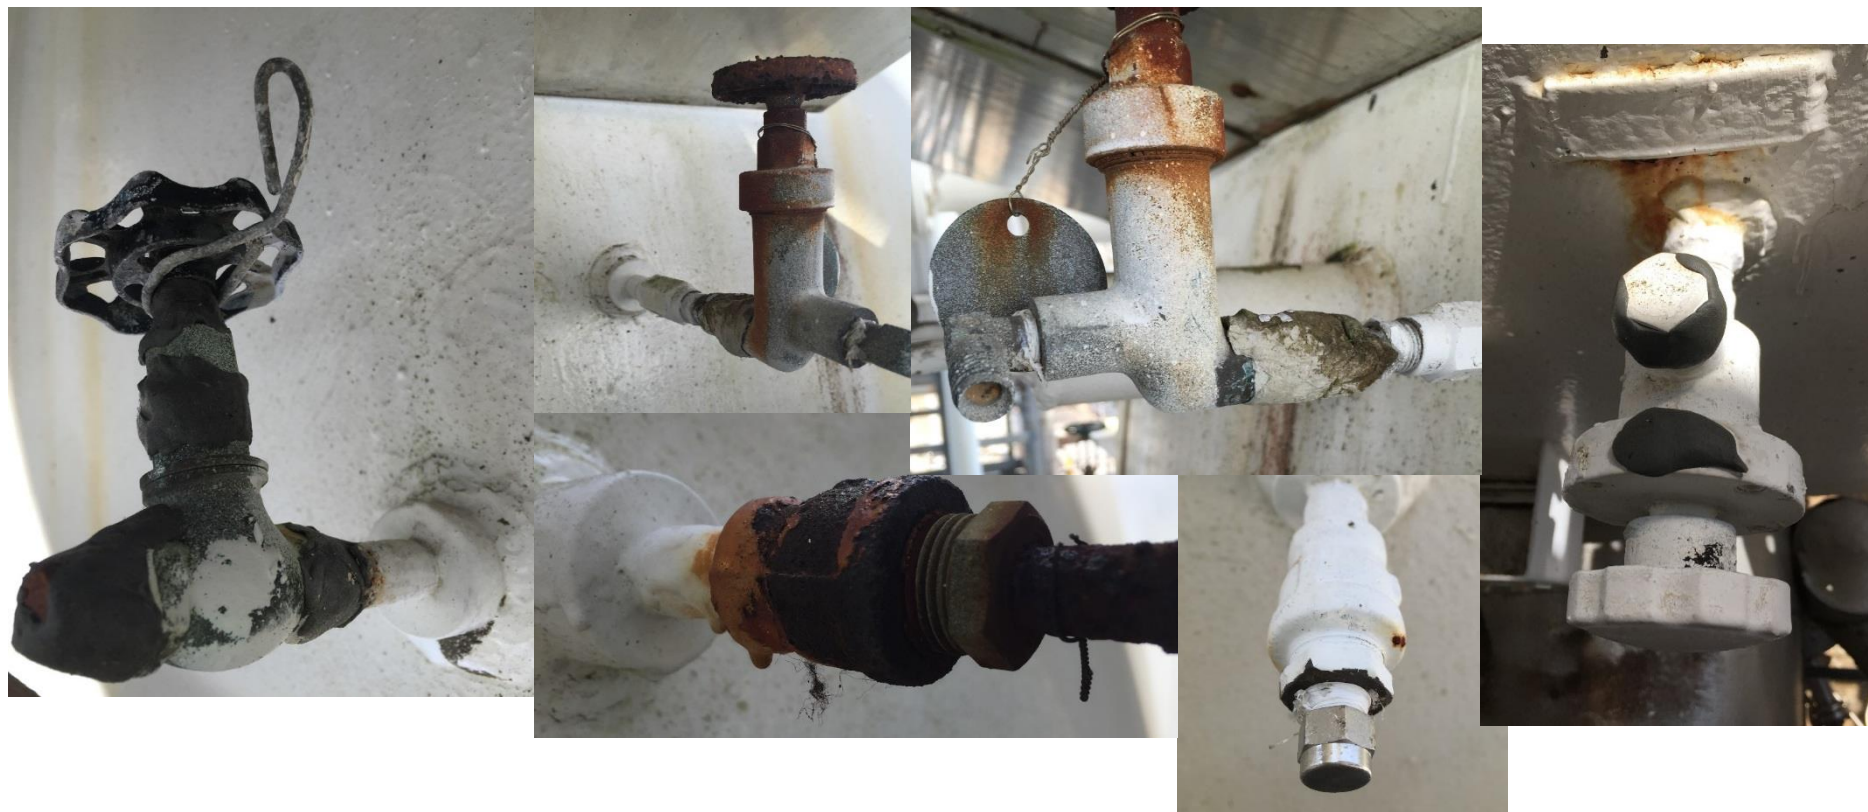
- Replace other leaking and leak-prone components.

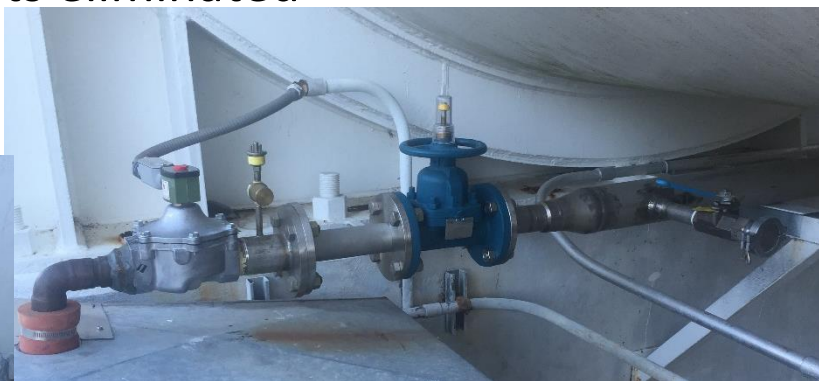
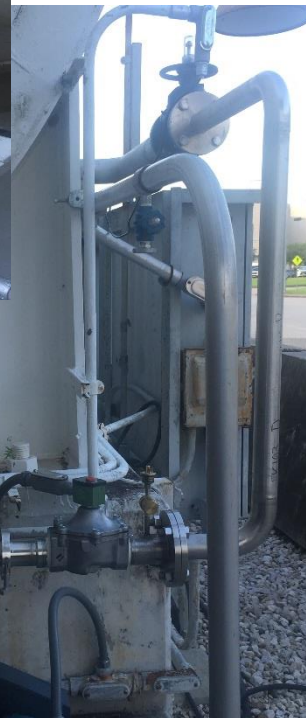
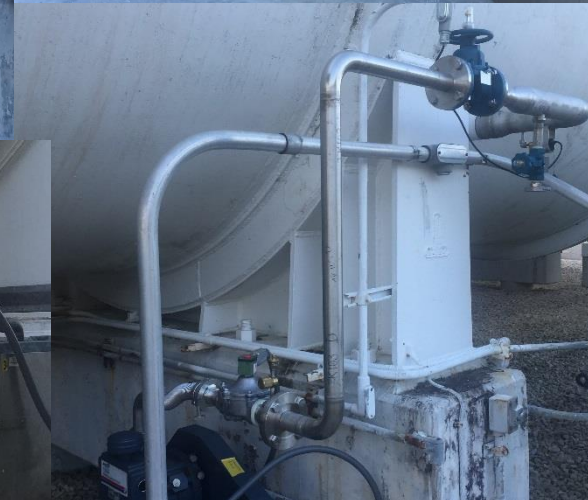
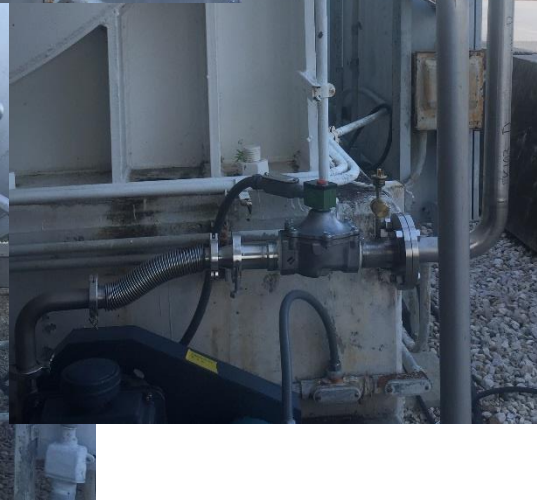
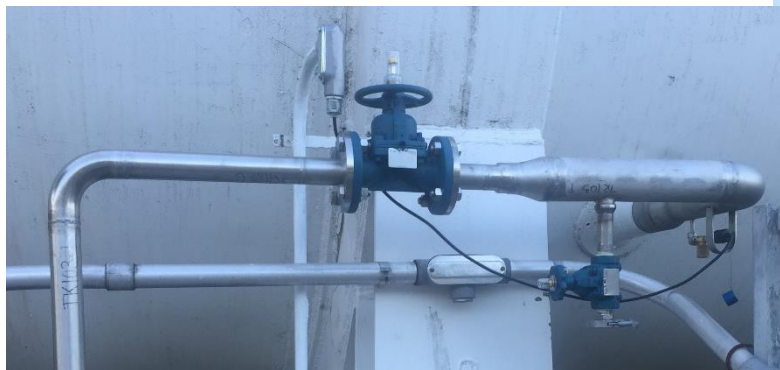
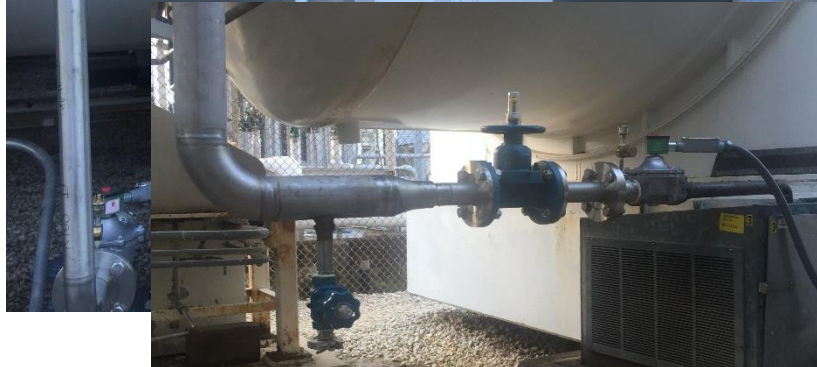
- Vacuum pipe spools replaced (all 6 tanks).
  - Mechanical joints/connections minimized
  - Unnecessary components eliminated

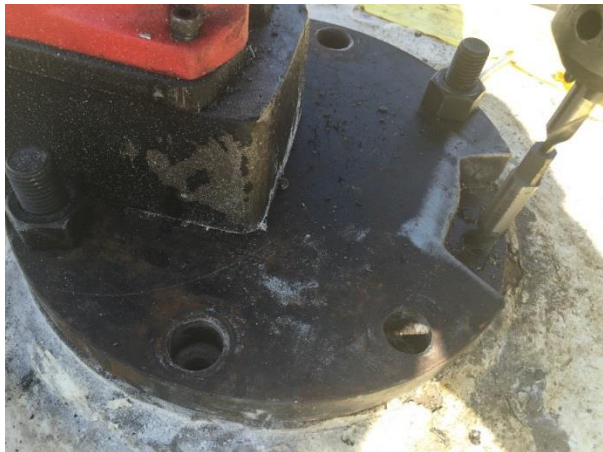
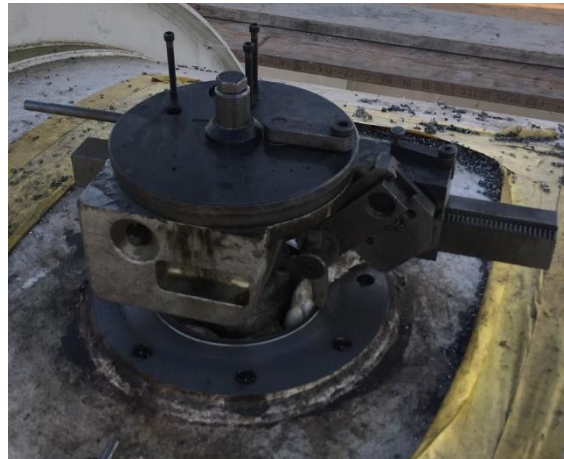
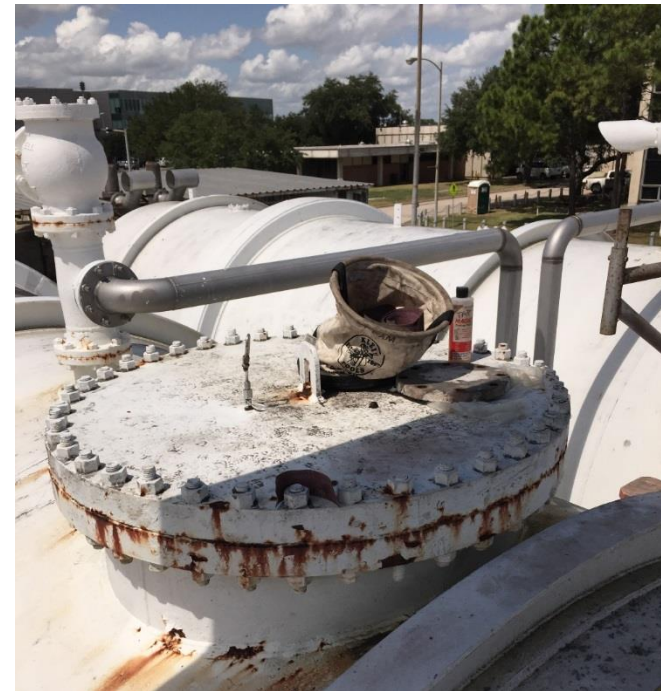
- Replace check valves on remaining 4 tanks with lift plates
  - Meeting relief requirements requires additional devices be installed
  - Multiple flanges on top of tanks available
  - Excessive corrosion on flanges requires stud extraction & resurfacing
